# FINAL REPORT

of the State Commission on Aircraft Accidents  
Investigation

## 2025-0023

Konner s.r.l, Konner K1-S19, SP-HTMS  
Stopin near Sierpc, 10 May 2025

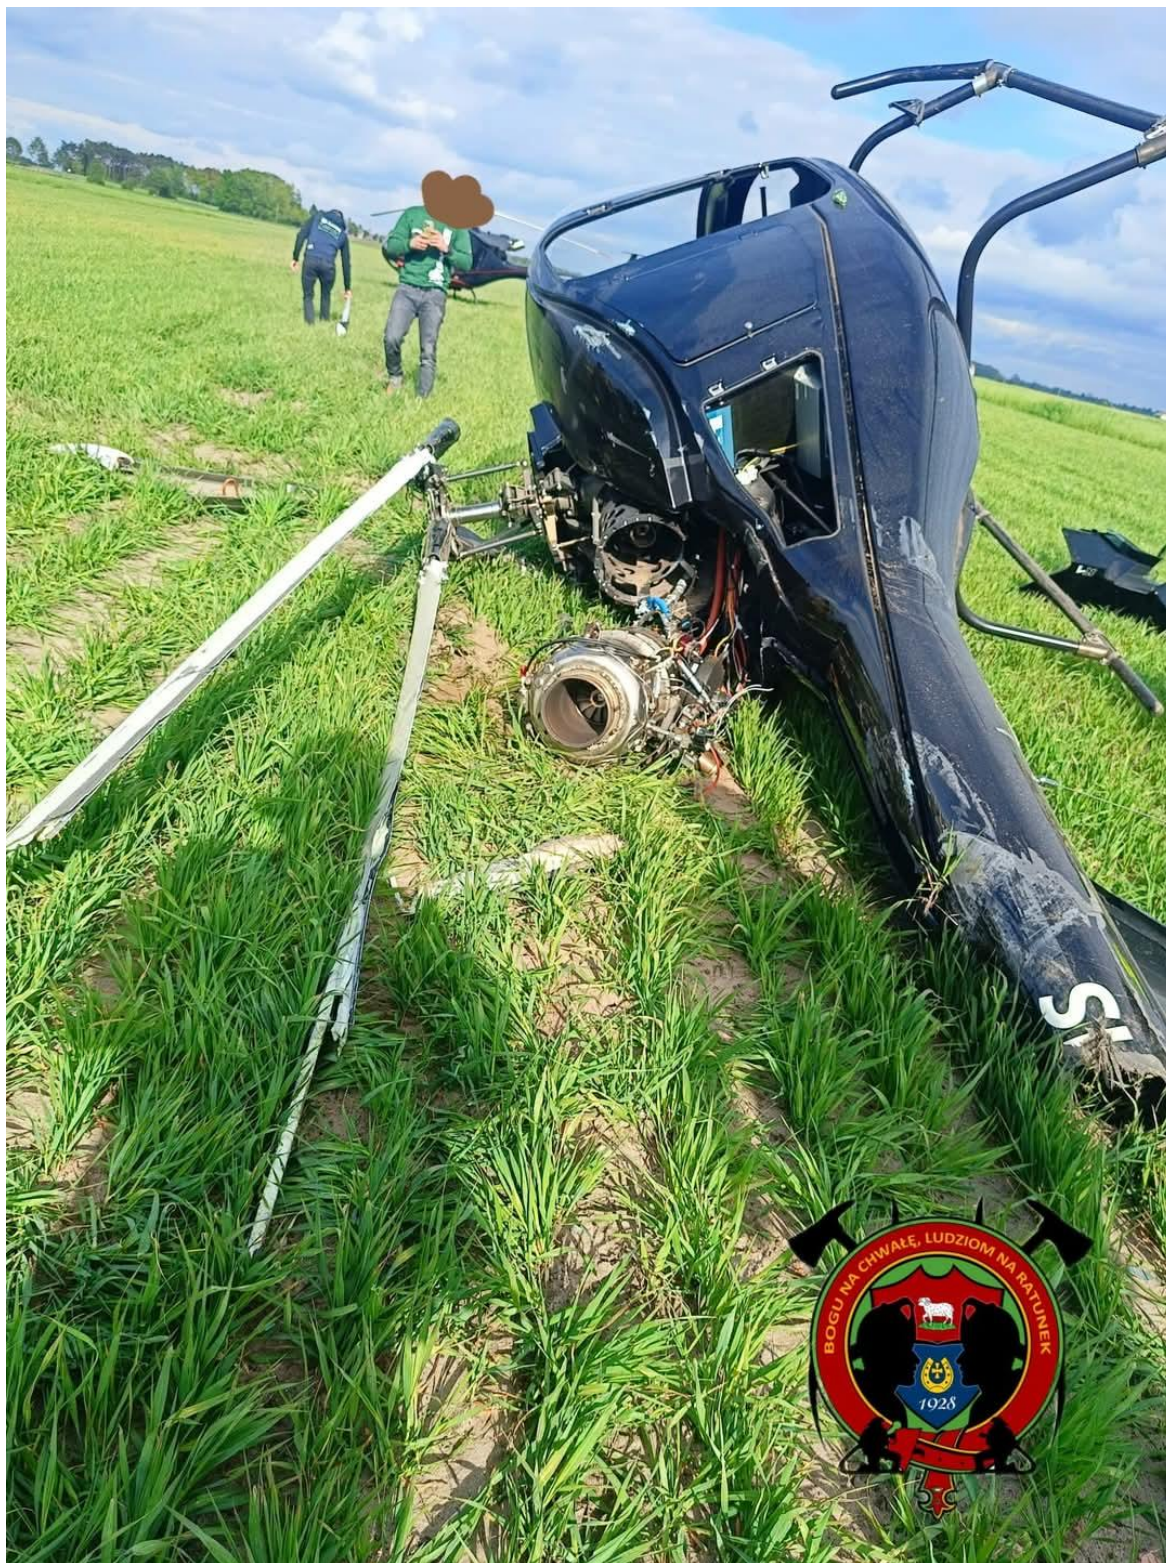
Fig. 1. SP-HTMS helicopter after landing in Stopin near Sierpc [source: OSP Rościszewo]

The helicopter sustained significant damage following its landing and rollover. The tail boom fractured (at mid-span) together with the shaft driving the tail gearbox, and both the tail rotor and the main rotor were destroyed. The engine broke free from its mounts, separating from the helicopter. In addition, the right cabin door, the left-hand baggage compartment door, and the right-hand access panel door were torn off. The cockpit glazing on the left side was damaged.

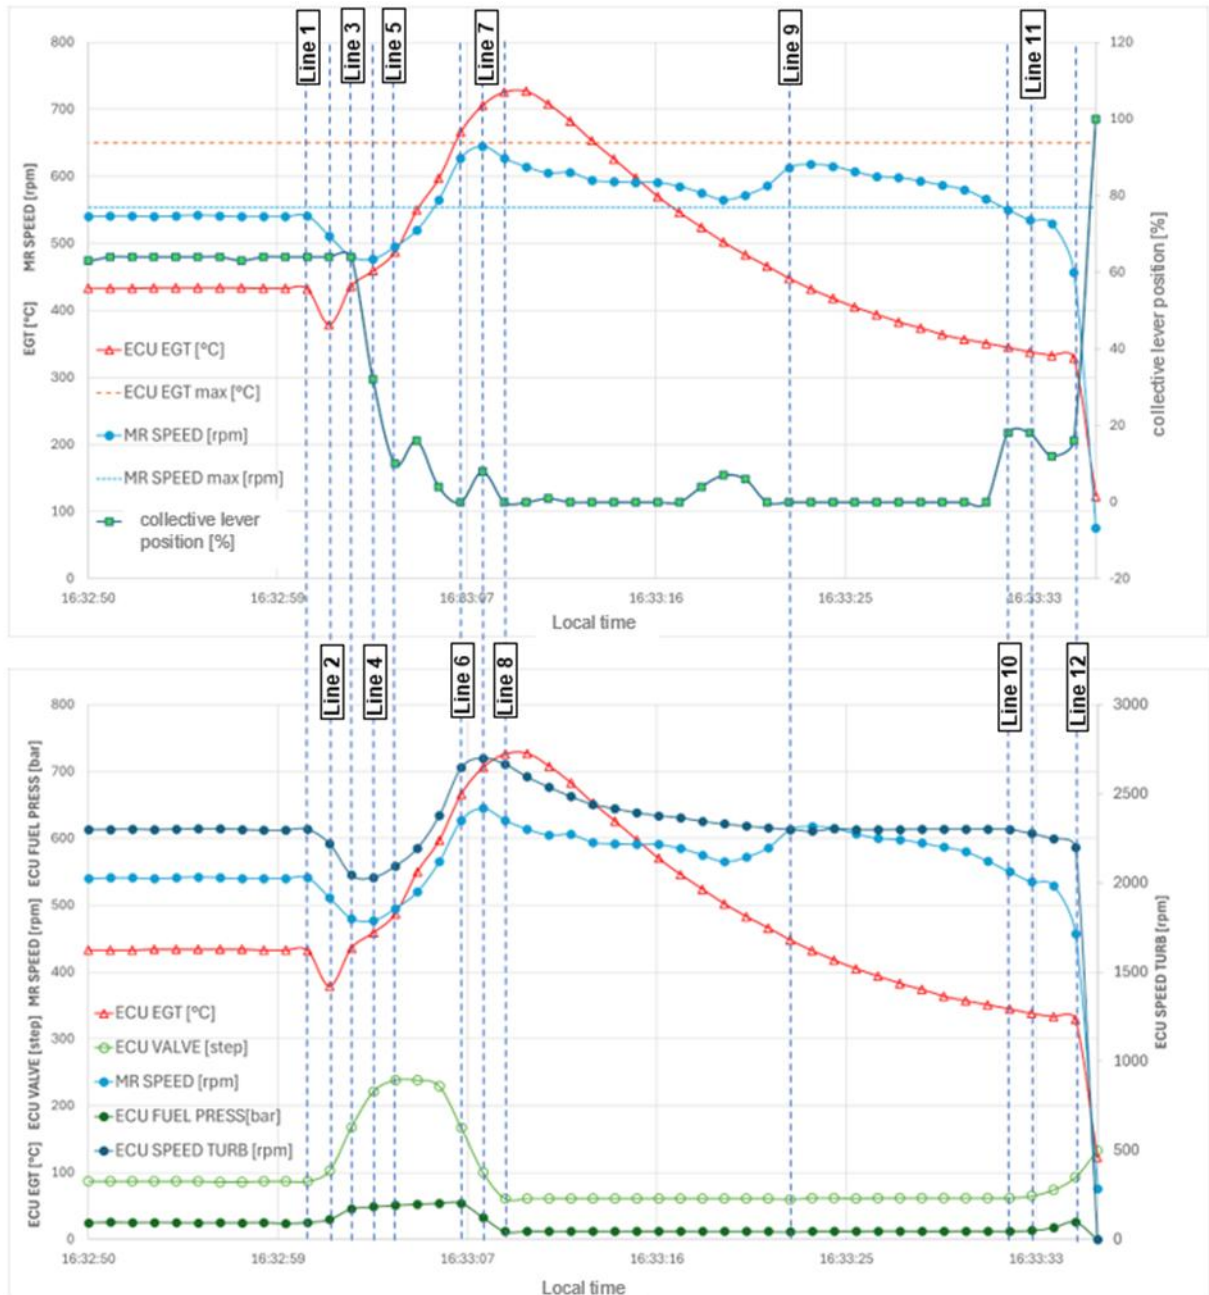
- (a) Line 1 (16:33:00) – stable flight parameters recorded for the last time. The forward speed recorded in the FADEC data was 97 KIAS.
- (b) Line 2 (16:33:01) – EGT reaches a minimum value of 379°C; turbine speed decreases to 2,220 rpm, while main rotor speed decreases to 511 rpm, with the main rotor collective pitch at 64%. FADEC increases fuel flow to 1.25 L/min and fuel pressure to 30.0 bar. A low main rotor speed alarm is activated for 3 seconds.

- (c) Line 3 (16:33:02) – EGT increases to 436°C, fuel flow to 1.52 L/min, and fuel pressure to 45.7 bar. Engine speed decreases to 2,044 rpm and main rotor speed drops below 89% to 480 rpm. Main rotor collective pitch at 64% – this is most likely a point at which the pilot decides to make an autorotation landing.

- (d) Line 4 (16:33:03) – the main rotor speed reaches its lowest value of 477 rpm, while the turbine speed reaches its lowest value of 2,031 rpm. The position of the collective lever is changed to 32%. EGT is rising.

- (e) Line 5 (16:33:04) – a warning is activated for 2 seconds that the fuel metering valve is open above 95% (fuel metering valve fully open). The turbine speed increases with the rotation of the main rotor. This was the result of FADEC reacting by opening the fuel valve to full flow in order to maintain the engine speed. The position of the collective lever is changed to 16%.

- (f) Line 6 (16:33:07) – the main rotor speed exceeds 108%, triggering the main rotor overspeed warning: “HIGH RPM MAIN ROTOR.” The collective lever is lowered to the minimum. Fuel pressure peaks and the exhaust gas temperature exceeds 650°C reaching 666°C. Turbine speed increases to 2,647 rpm. After 2,500 rpm is exceeded, the “ERROR OVERSPEED PROTECTION” alarm is recorded for 2 seconds.

- (g) Line 7 (16:33:08) – turbine speed peaks at 2,700 rpm, with rotor rpm exceeding 109% and also peaking. FADEC reduces the opening of the fuel metering valve to protect against overspeed, while ensuring that the turbine does not shut down until it returns to the correct parameters. The position of the collective lever is changed to 4%. The forward speed increases to 113 KIAS.

Fig. 2. Graph of EGT (*ECU EGT*), main rotor speed (*MR SPEED*), and the collective lever position [source: FADEC].

Fig. 3. Graph of EGT (*ECU EGT*), fuel metering valve opening (*ECU VALVE*), main rotor speed (*MR SPEED*), fuel pressure (*ECU FUEL PRESS*), and turbine speed (*ECU SPEED TURB*) [source: FADEC].

- (h) Line 8 (16:33:09) – EGT reaches a maximum value of 727°C, main rotor speed is still above 109%. The collective lever is lowered to the minimum. The forward speed exceeds 115 KIAS increasing to 117 KIAS over the next 3 seconds. After 1 second, the warning “EGT overheating protection” is activated. For 4 seconds, the ECU takes action when the 710°C EGT threshold is exceeded, reducing the opening of the fuel valve while ensuring that the turbine does not shut down.

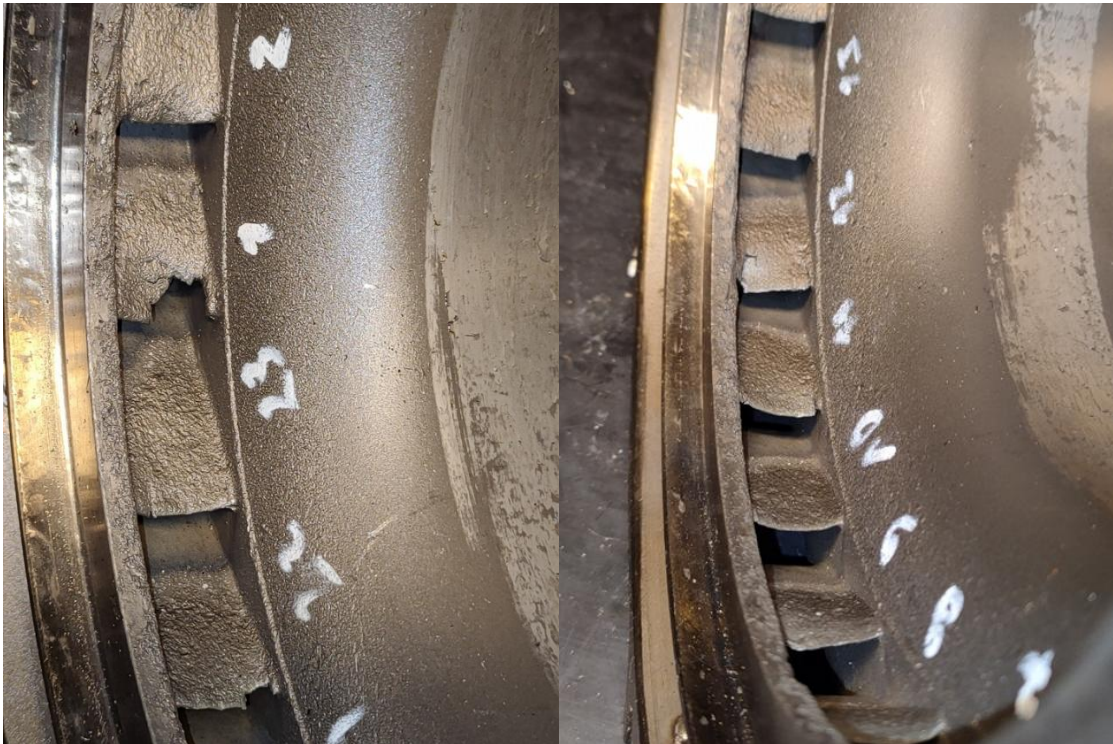
- (1) Turbine stator (Fig. 4) – numerous cracks, deformations, and bending of the vane edges, with evidence of overheating and localized material burn-through. The damage is thermal in nature and is consistent with exposure to high temperatures.

Fig. 4. SP-HTMS helicopter turbine stator [source: PKBWL].

The damage found during the visual inspection – melted turbine blades, shroud spalling, stator deformation – is consistent with FADEC data indicating prolonged exceedance of turbine speed and EGT.

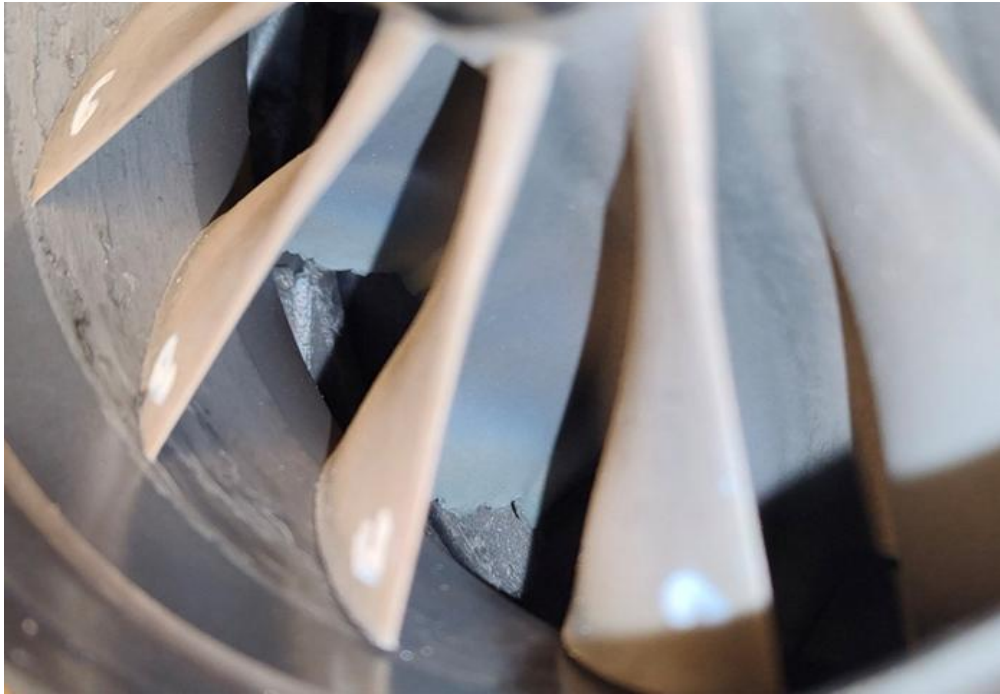
- (2) Turbine shroud (Fig. 5) – wear of the internal surfaces and material spalling. The damage is typical of contact between the turbine blades and the casing, caused by blade elongation due to excessive temperature.

Fig. 5. SP-HTMS helicopter turbine shroud [source: PKBWL].

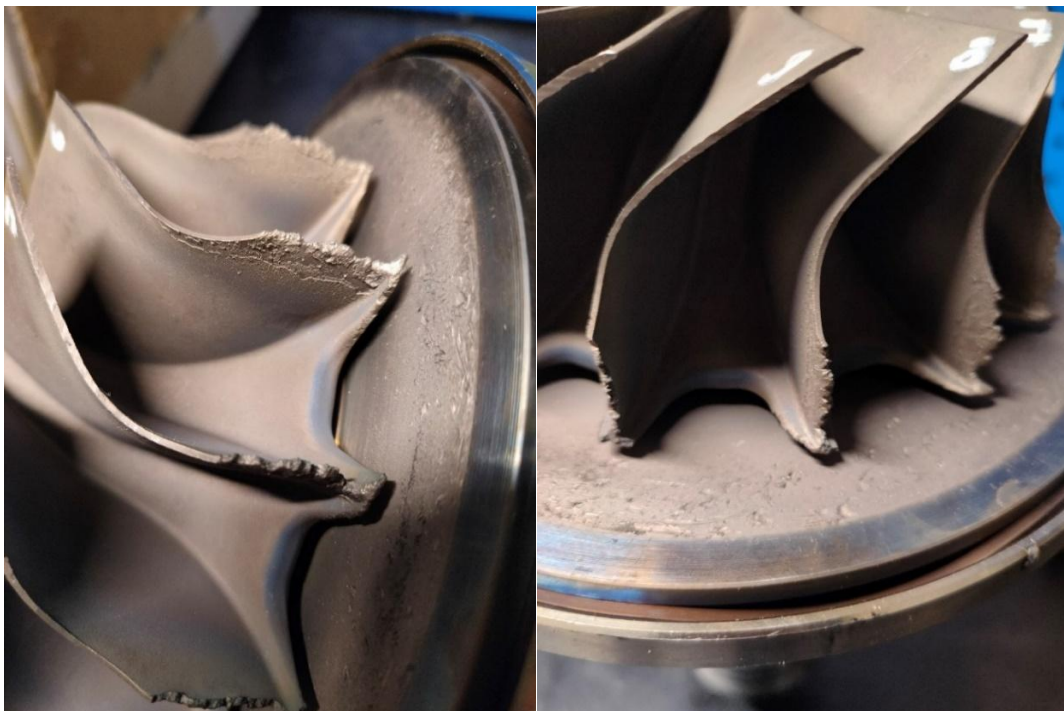
- (3) Turbine rotor (Fig. 6) – the blades were partially melted and deformed. The damage clearly indicates turbine overheating and significant exceedance of the permissible parameters (EGT, rotational speed).

Fig. 6. SP-HTMS helicopter turbine rotator [source: PKBWL].
